DESIGN OF SELECTED HELICOPTER COMPONENTS
FOR EASE OF REPAIR

KAMAN AEROSPACE CORPORATION
BLOOMFIELD, CONNECTICUT

JSAAMRDL-TR -76-34

Final Report for Period April 1975 - May 1976

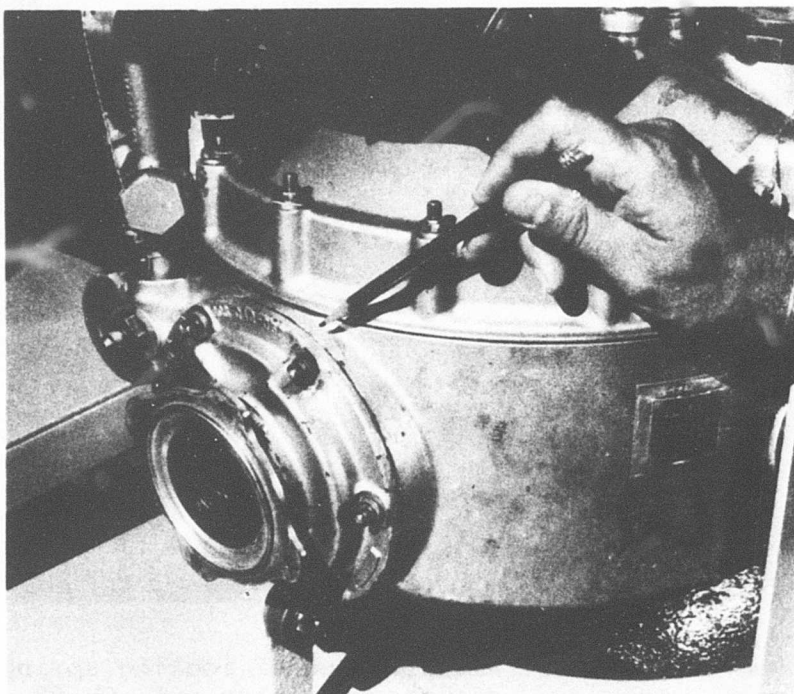
Figure 9. Location of laminated shims behind input bearing/seal housing, OH-58 transmission.

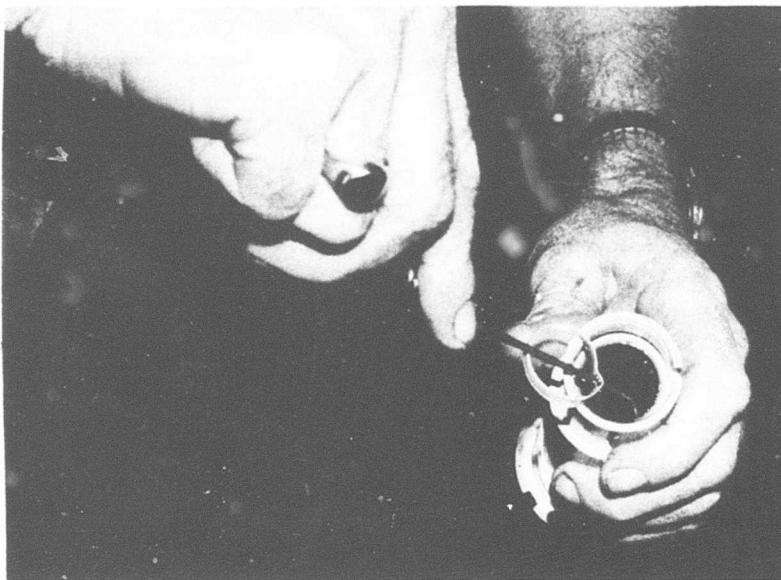
Figure 29. Use of pick to remove hydraulic actuator O-ring seals.

Valve body seals in the OH-58 hydraulic actuator, and head and pilot valve seals in the UH-1 and AH-1 hydraulic actuators, are difficult to extract from the circumferential grooves in the lower ends of the valve bores. The bore diameter is small (roughly 1/2 inch) and the seal protrudes very little above the groove. Mechanics resort to using hook-shaped picks (Figure 29) to extract the seals, and scratches on the highly
